Water ingress to the caliper's sensor will cause irregular readings on the dash and/or sensor testing unit. This can also cause corrosion and prevent the caliper from functioning properly. When replacing the brake caliper, inspect the vehicle's sensor connector for signs of a damaged o-ring.

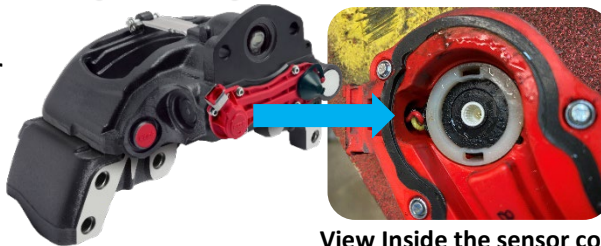
View Inside the sensor cover

A few drops of water within the caliper can cause faulty sensor readings and form rust on the internal components.

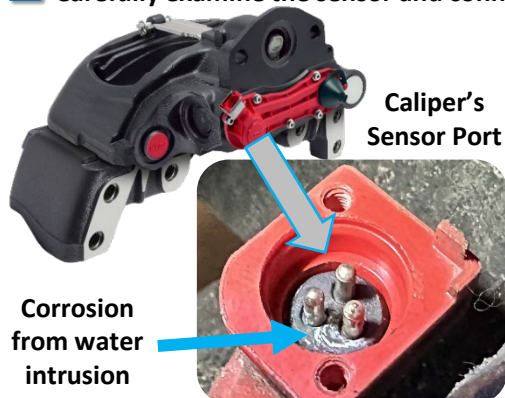
Caliper's Sensor Port

- The most common water entrance point to an ADB caliper's sensor is the vehicle's wiring connector o-ring. Carefully examine the sensor and connector for corrosion or signs of moisture.

Corrosion from water intrusion

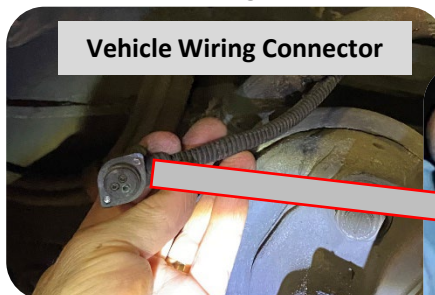
Vehicle Wiring Connector

Corrosion on the sensor or connector's terminals is a clear indication of water intrusion.

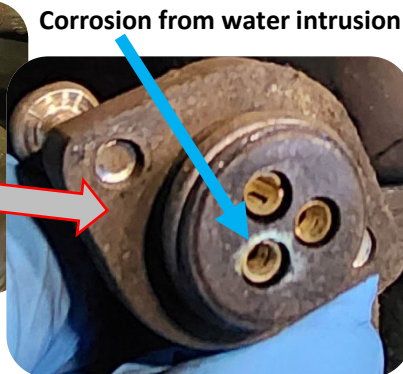
Corrosion from water intrusion

- Inspect the o-ring installed on the vehicle's wiring connector for damage when installing a new caliper. Replace the o-ring if any damage is found

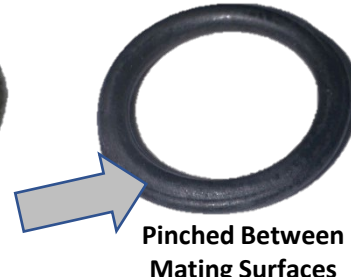
Pinched Between Mating Surfaces

- For best results, replace the o-ring installed on the vehicle's wiring connector each time a new ADB caliper is installed.

After lubricating the o-ring and connector terminals, press the connector firmly into the caliper's sensor and hold in place while evenly tightening the fasteners. This will help prevent the connector from rocking, thus keeping the o-ring from bulging out or pinching between the mating surfaces
