# Caliper Maintenance and Troubleshooting

Webb Air Disc Brakes

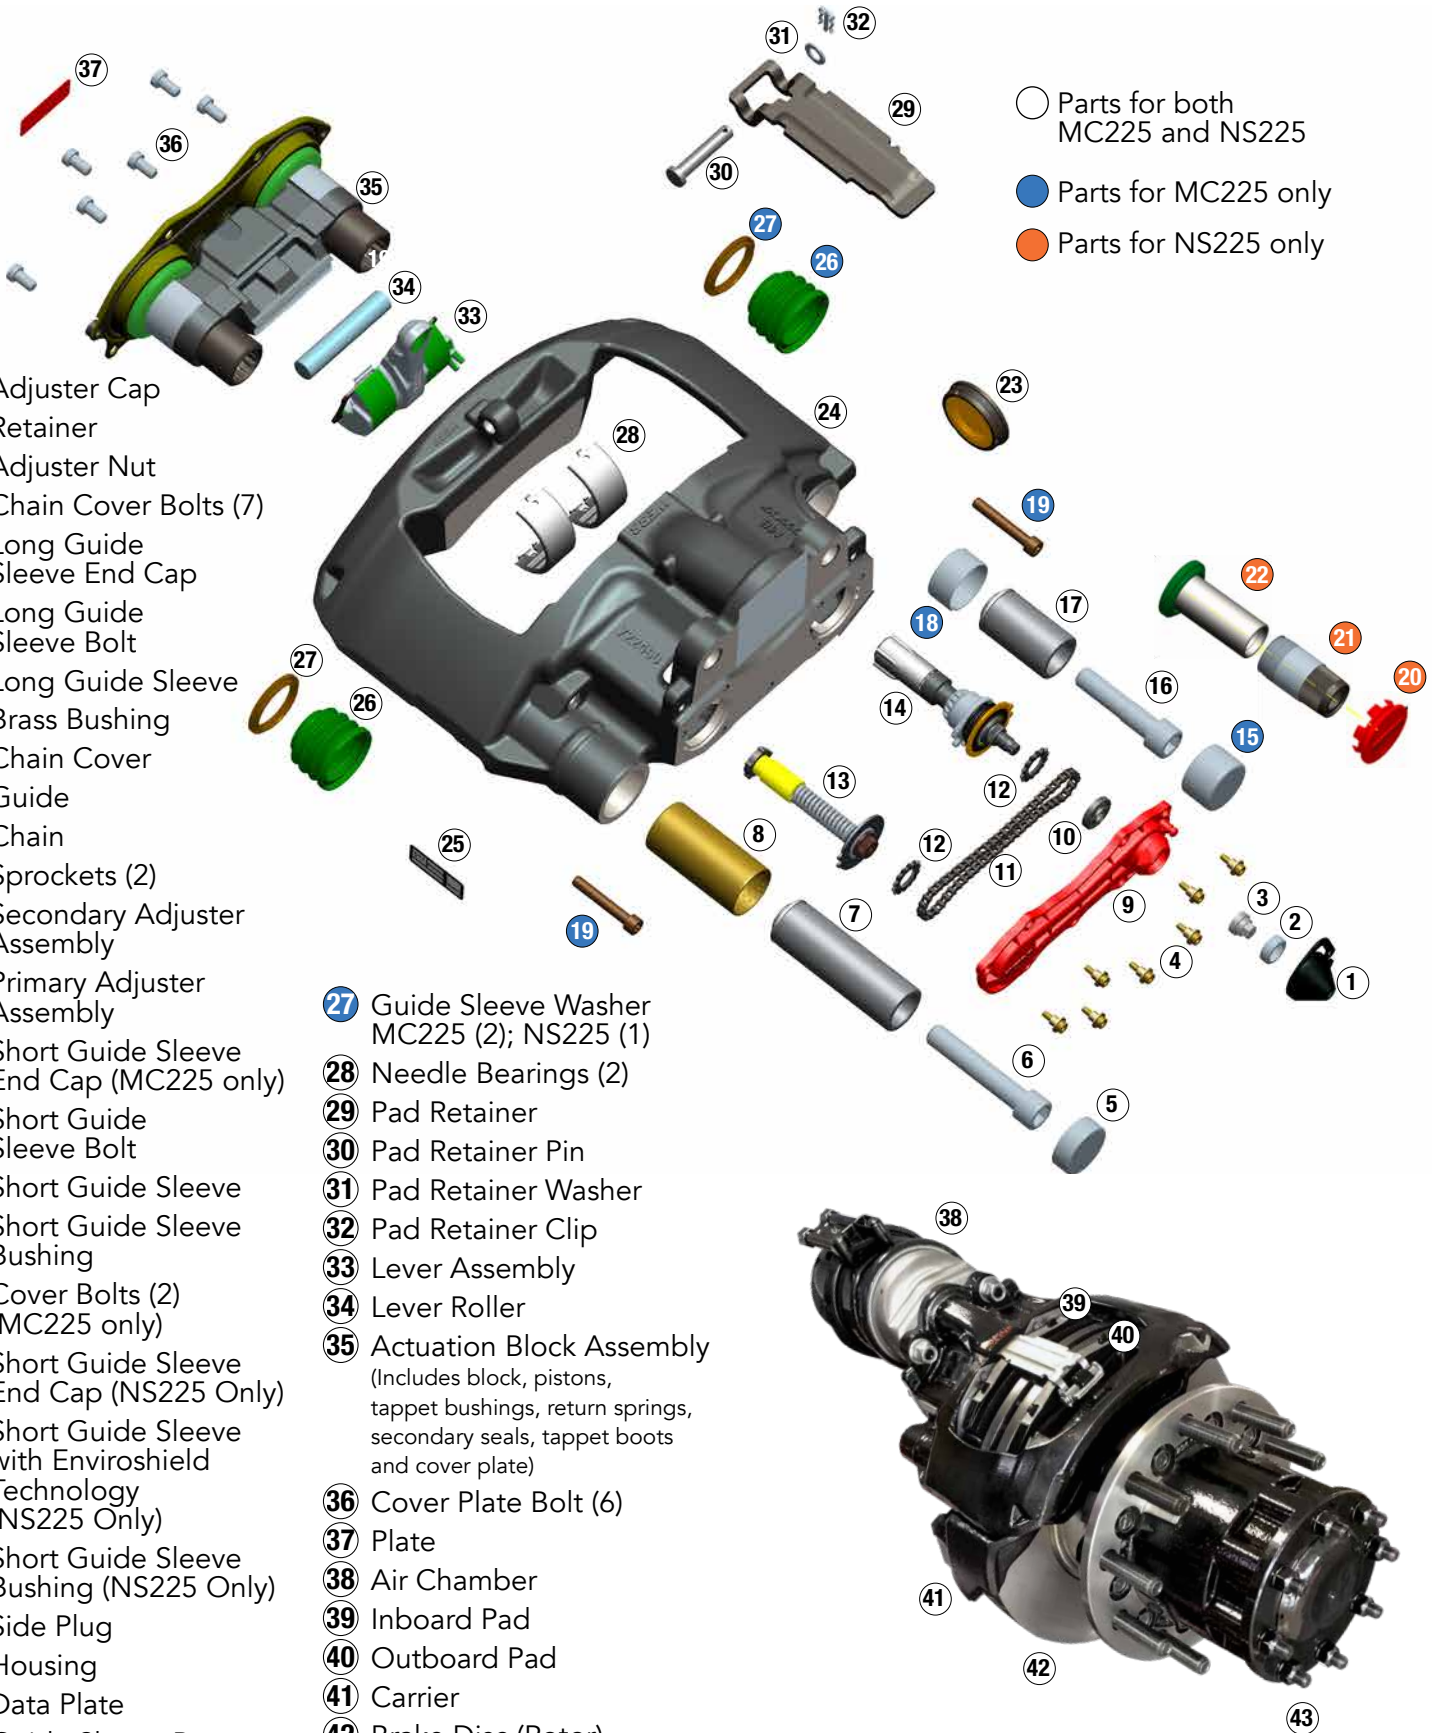
- ① Adjuster Cap
- ② Retainer
- ③ Adjuster Nut
- ④ Chain Cover Bolts (7)
- ⑤ Long Guide Sleeve End Cap
- ⑥ Long Guide Sleeve Bolt
- ⑦ Long Guide Sleeve
- ⑧ Brass Bushing
- ⑨ Chain Cover
- ⑩ Guide
- ⑪ Chain
- ⑫ Sprockets (2)
- ⑬ Secondary Adjuster Assembly
- ⑭ Primary Adjuster Assembly
- ⑮ Short Guide Sleeve End Cap (MC225 only)
- ⑯ Short Guide Sleeve Bolt
- ⑰ Short Guide Sleeve
- ⑱ Short Guide Sleeve Bushing
- ⑲ Cover Bolts (2) (MC225 only)
- ⑳ Short Guide Sleeve End Cap (NS225 Only)
- ㉑ Short Guide Sleeve with Enviroshield Technology (NS225 Only)
- ㉒ Short Guide Sleeve Bushing (NS225 Only)
- ㉓ Side Plug
- ㉔ Housing
- ㉕ Data Plate
- ㉖ Guide Sleeve Boots MC225 (2); NS225 (1)

- ㉗ Guide Sleeve Washer MC225 (2); NS225 (1)
- ㉘ Needle Bearings (2)
- ㉙ Pad Retainer
- ㉚ Pad Retainer Pin
- ㉛ Pad Retainer Washer
- ㉜ Pad Retainer Clip
- ㉝ Lever Assembly
- ㉞ Lever Roller
- ㉟ Actuation Block Assembly (Includes block, pistons, tappet bushings, return springs, secondary seals, tappet boots and cover plate)
- ㊱ Cover Plate Bolt (6)
- ㊲ Plate
- ㊳ Air Chamber
- ㊴ Inboard Pad
- ㊵ Outboard Pad
- ㊶ Carrier
- ㊷ Brake Disc (Rotor)
- ㊸ Hub Assembly

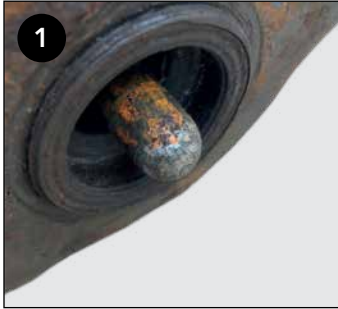
1 Check for signs of water damage on the air chamber pushrod.

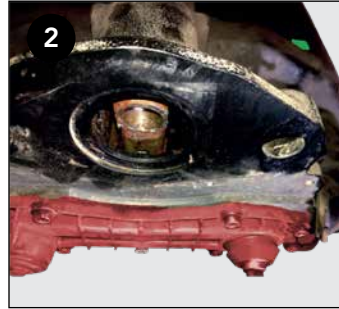
2 Check for rust on the lever of the caliper being replaced.

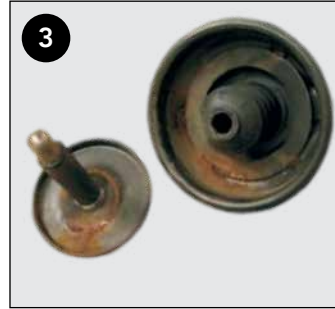
3 Damaged air chamber boots will cause water ingress to the caliper.

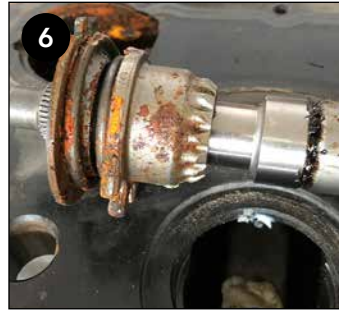
6 A major cause of caliper failure is due to water entry into the mechanism. 2ml of water is enough to prevent the caliper from functioning properly.

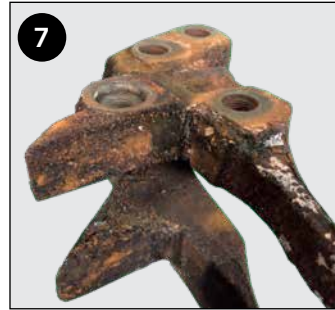
7 Check the general condition of the carrier and clean if required. Ensure the pads are sitting correctly in the carrier.

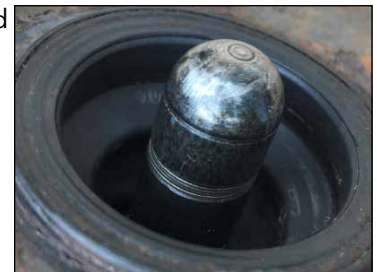
The inside of the boot and the pushrod should look like the image at right.

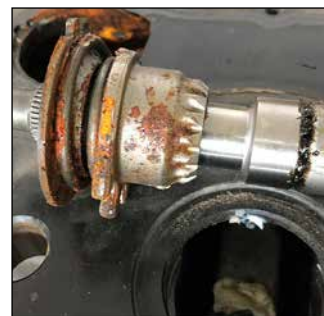
*This brake faulted after less than two weeks of service. Water entered through the air chamber seal, which created an electrical fault. The issue was highlighted as a "worn-out pad" signal in the cab.*

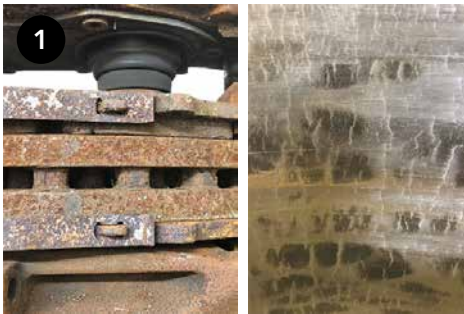
- 1 If sliding becomes stiff or seized, the first effect will be the outboard pad showing signs of higher wear than the inboard pad, and the brake will run hotter than normal – heat marks or blue spots may be seen on the disc.
- 2 During the vehicle's regular inspection, try to get a feel for the condition of the caliper guide sleeves. Standing in the inspection pit, and with the park brakes released (make sure the vehicle is chocked and safe!), the mechanic can apply force to move the air chamber/caliper on the guide sleeves. If the caliper can be moved easily the pins are not seized, while if it is stiff then further investigation will be needed.

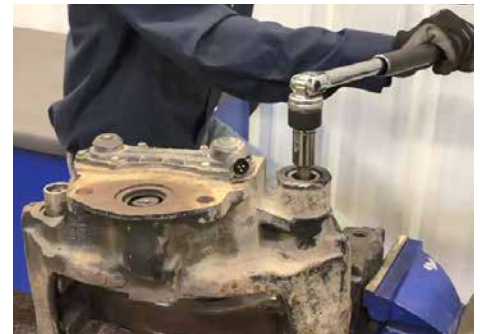
- 4 When tightening the guide sleeve bolts, ensure the carrier is securely clamped in a vice at the same side of the carrier being tightened – the carrier can twist or bend (due to the high load applied when tightening the bolt) if this is not followed. If the carrier is still mounted to the axle, there is no risk. Ensure that the guide sleeve nearest the vice (left hand side of the image below) is the one torqued.

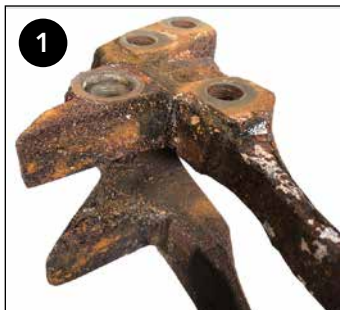
1  
Abutments are often heavily corroded.

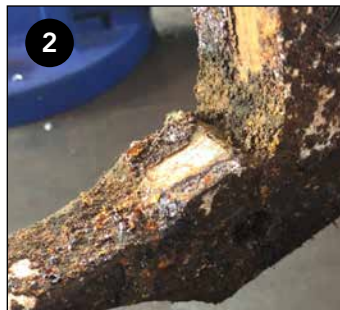
2  
Check for steps in the abutment that can snag the pads.

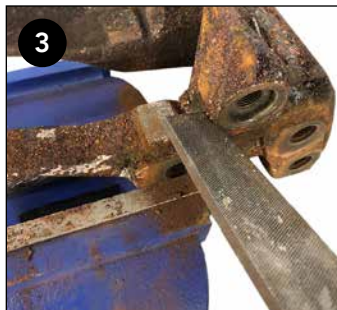
3  
Carefully clean the abutments with a wire brush, emery cloth or file - be careful not to remove the core metal.

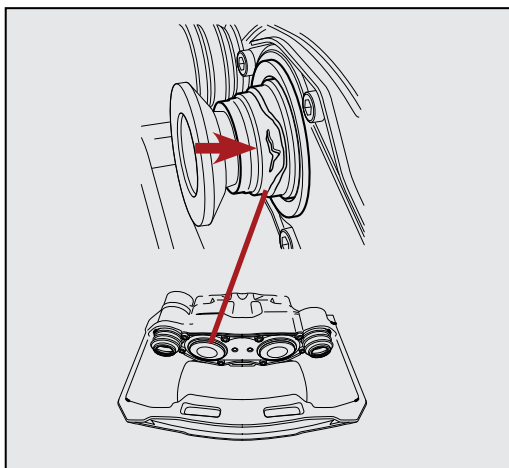
Check Tappet Boots  
for Damage
